TECHNICAL MEMORANDUM 1204
LOTT Wastewater Resource Management Plan

March 26, 1999

Robinson & Noble, Inc.
Tacoma, WA

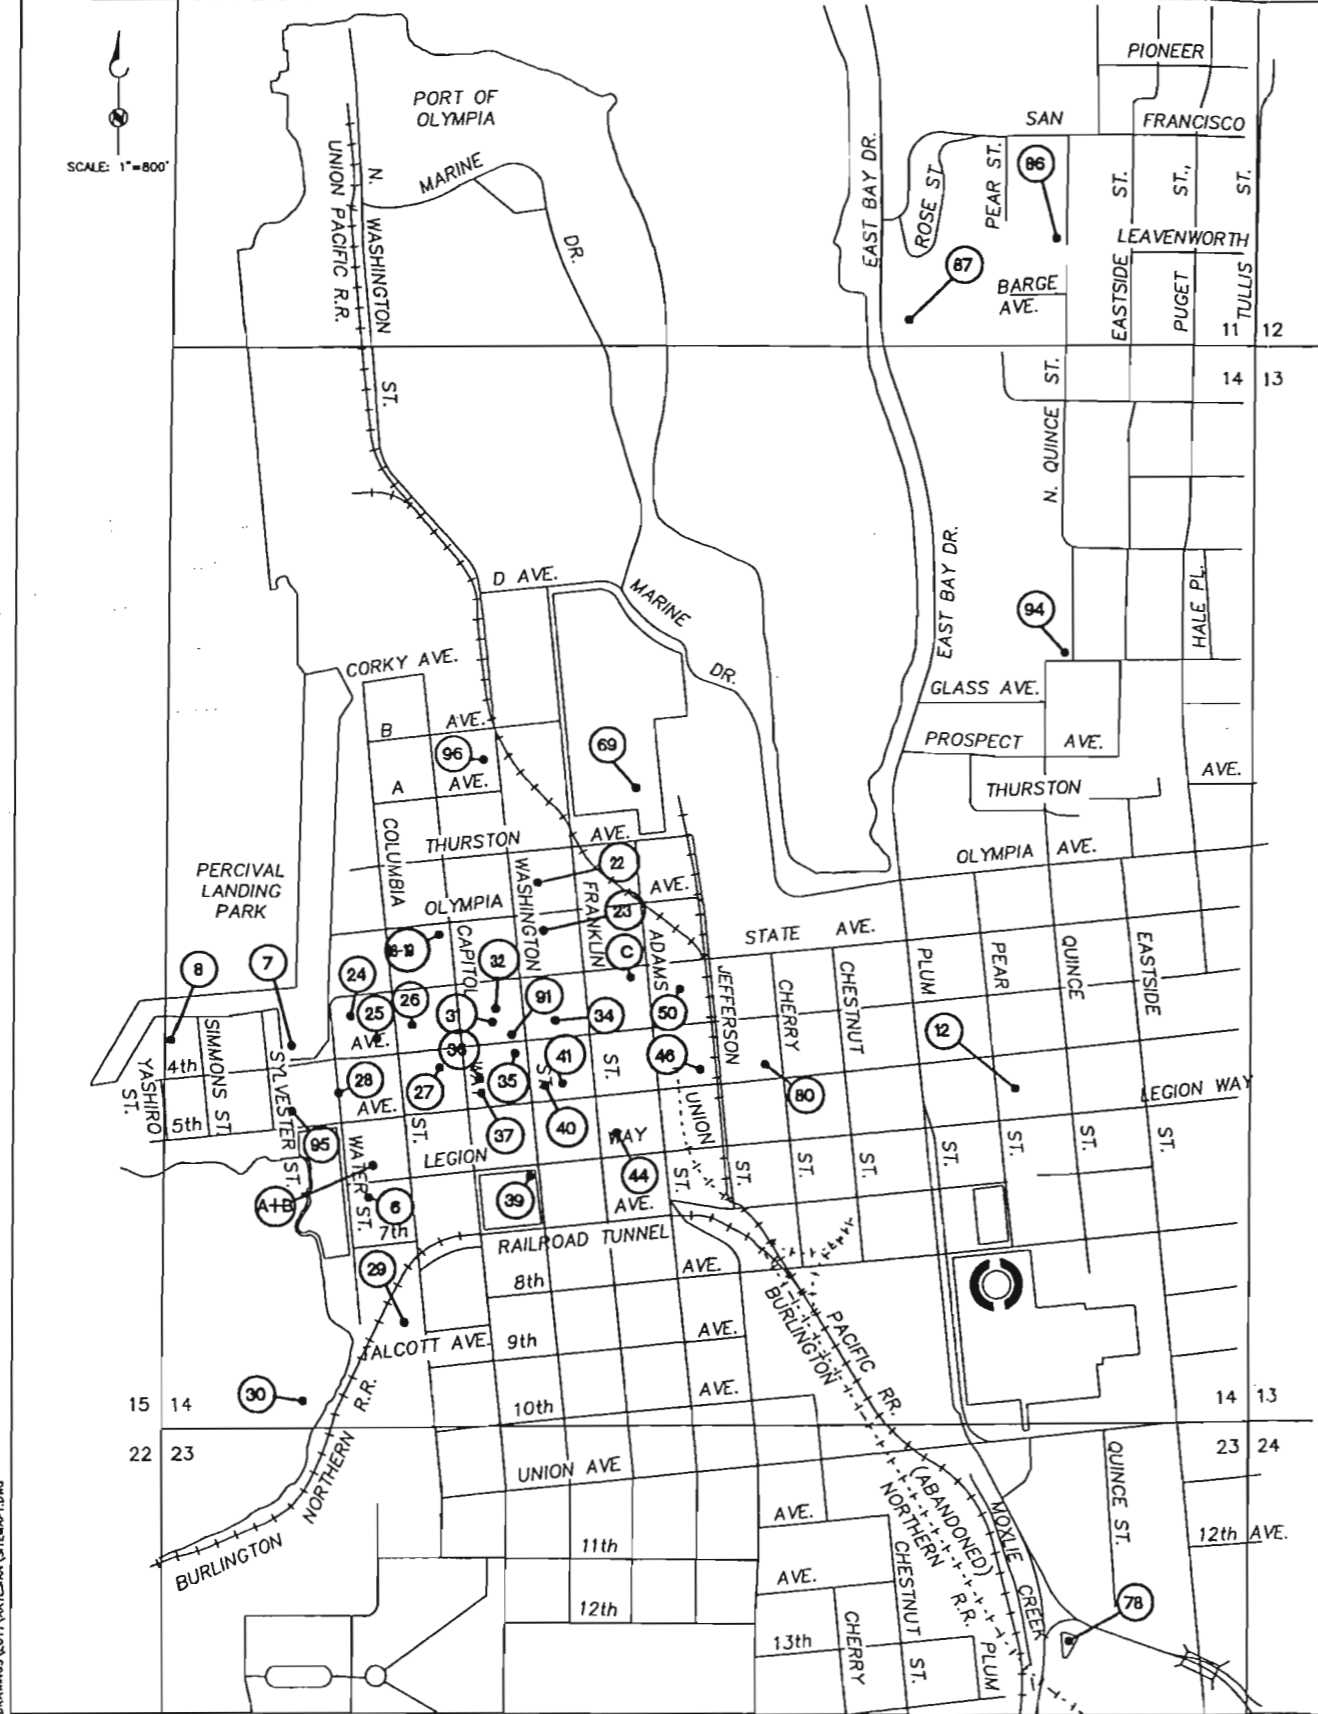
FIGURE 1-1

Our survey investigated 36 reported well sites, locating 19 wells (at 18 sites) and three spring sites. Three of the sites investigated have wells that were apparently previously unknown. Figure 1-1 illustrates the locations of the wells and springs covered in this effort. Figure 1-2 is a reproduction of the well location map from the 1994 Artesian Well Survey by Thurston County Environmental Health Department (TCEHD). That effort originally identified 94 well sites or springs based on information collected in the field and from two previous surveys by the City of Olympia (the first a 1939 to 1943 survey as summarized in Fieldbook 17, and the later an undated survey). The figure shows 86 of the 94 sites. The 1994 survey identified 31 wells as field located.

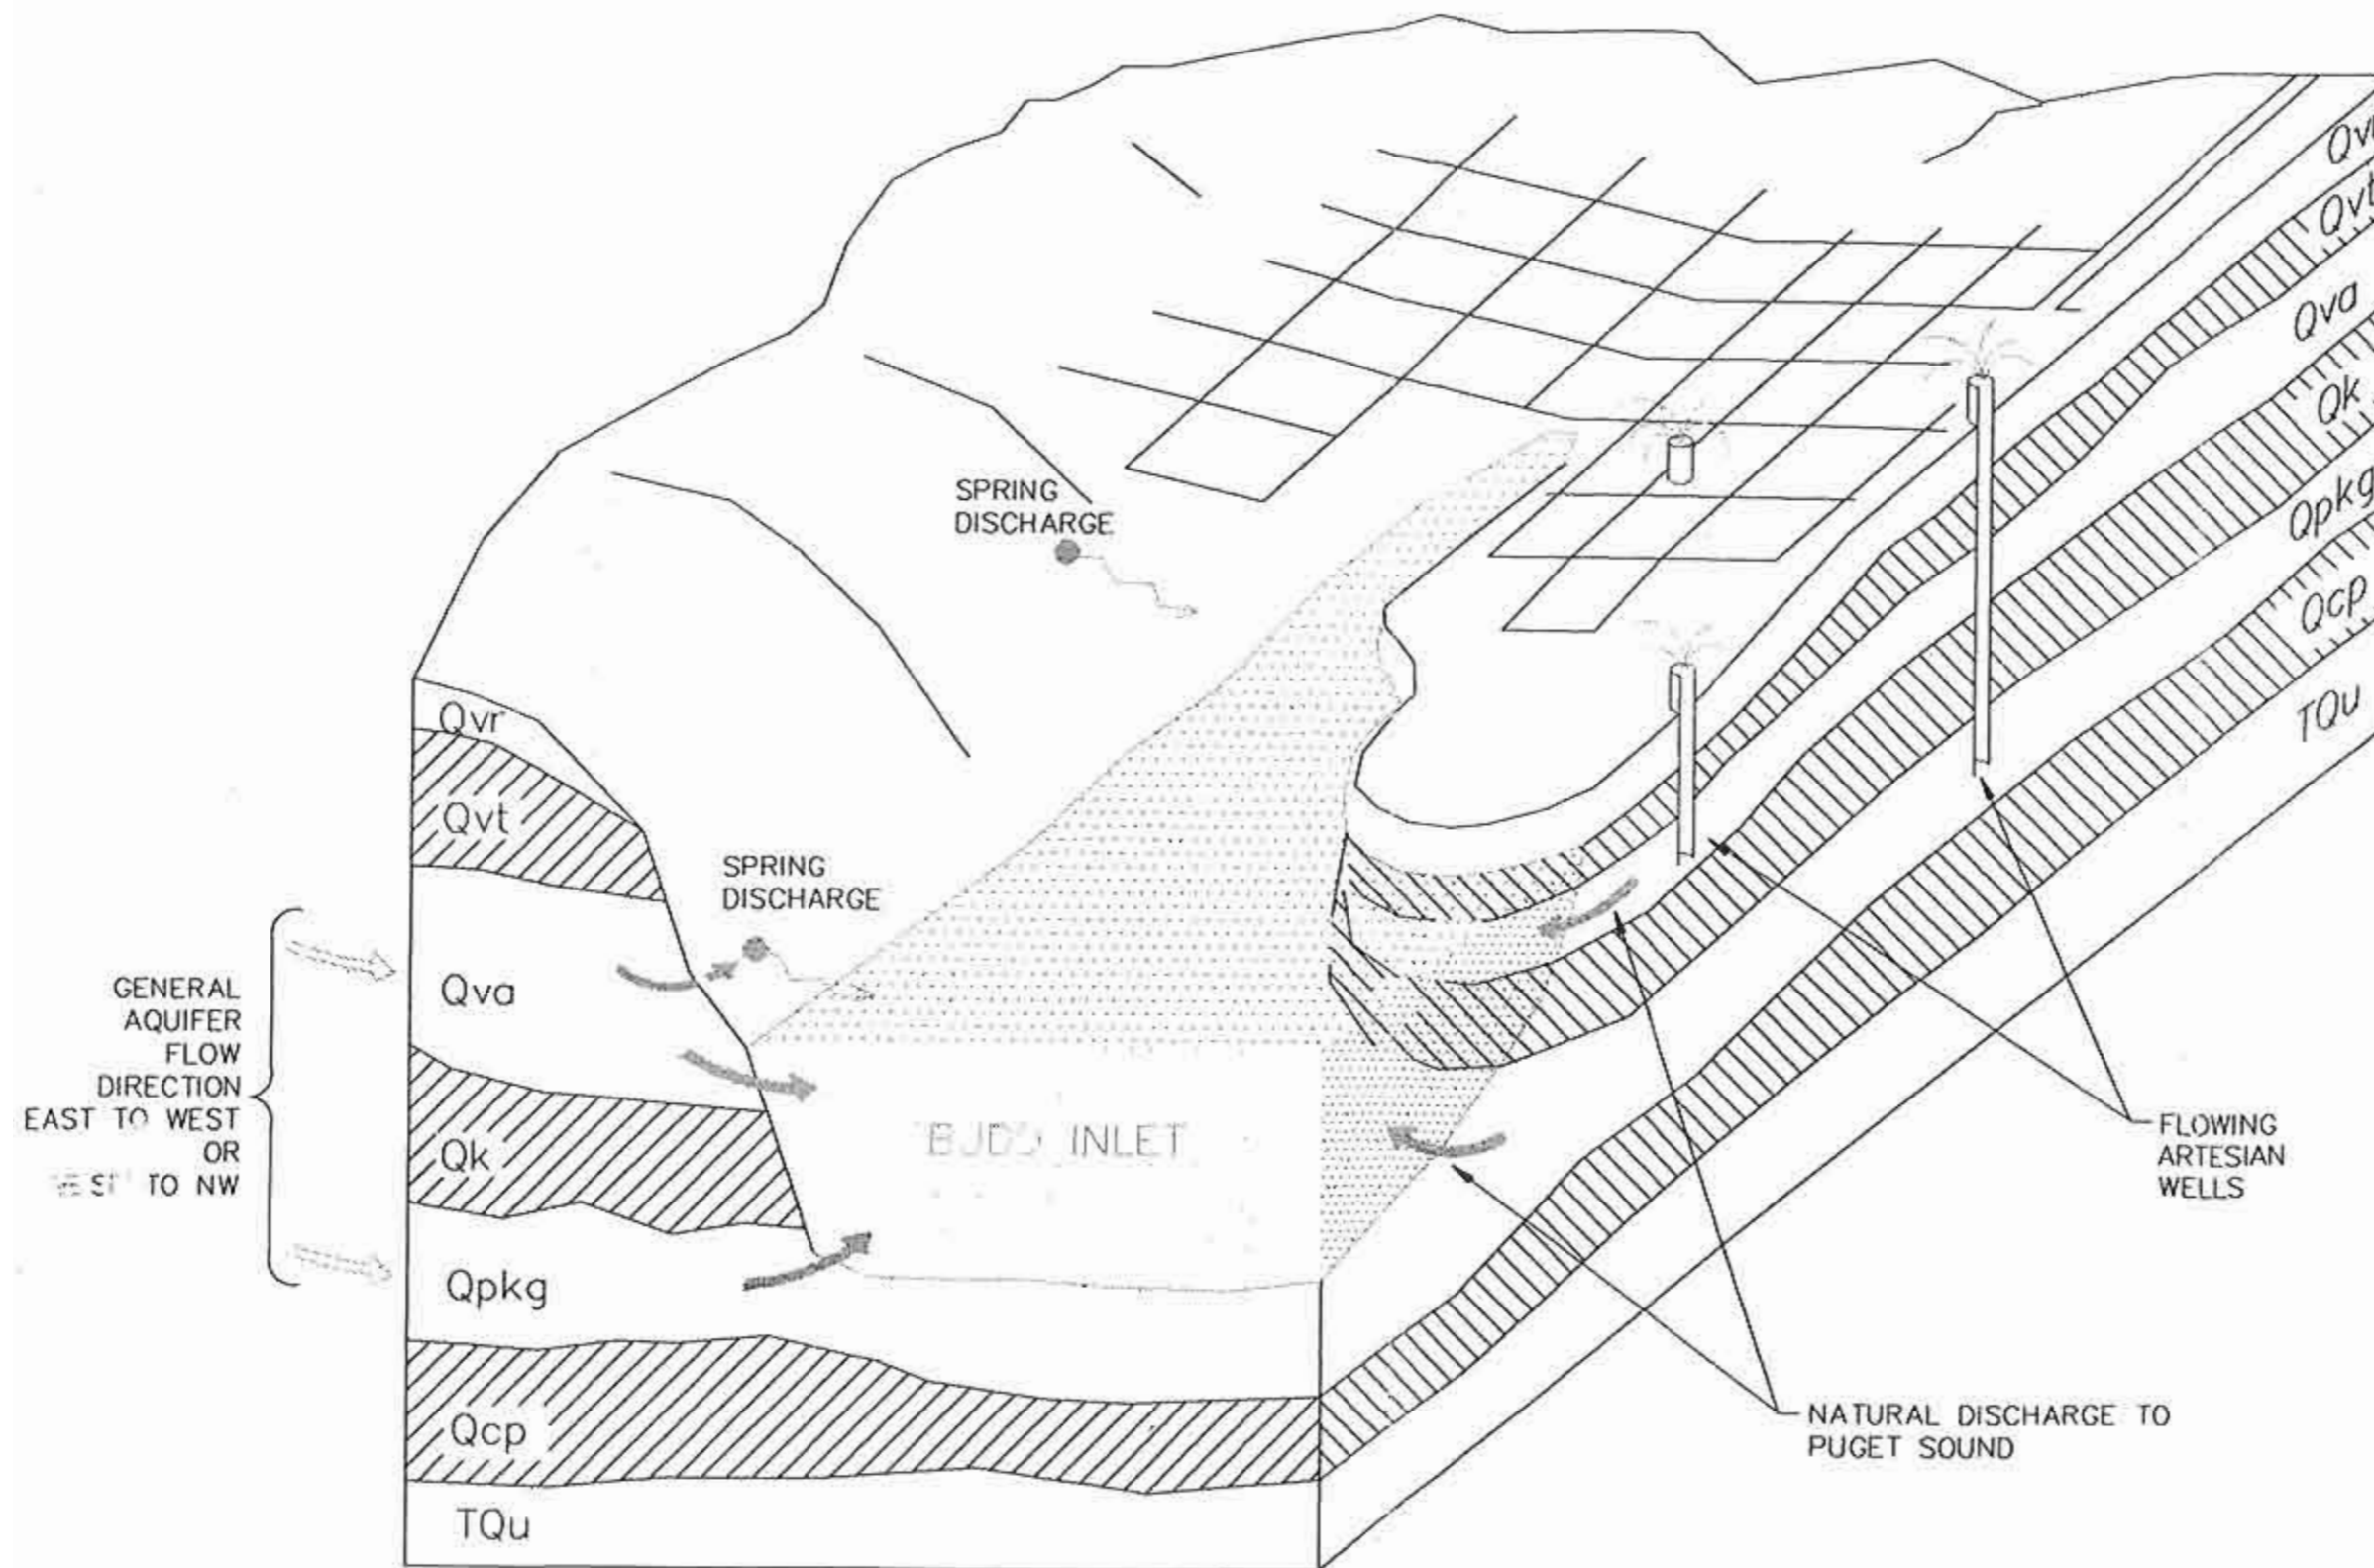
These units are fully described in Technical Memorandum 1200. For this study, insufficient data was available to determine the specific details of the units as they exist beneath the study area. Assumptions of the hydrogeology were made based on our previous work (Task 1200 in particular) and other related regional studies. In order to illustrate the relationship of the hydrostratigraphic units with the downtown area, a conceptual model of the area was created. This is presented graphically as Figure 1-3.

Within the study area, artesian wells tap the Qva Aquifer, Qpkg Aquifer, and aquifer systems of the undifferentiated sediments. This interpretation is based primarily on the reported depths of the wells and the general thicknesses of the hydrostratigraphic units. Because these wells are believed to be completed in three different aquifer systems, well characteristics (flow, water quality, response to recharge, risk of contamination) are variable from well to well. More detailed definitions of the units from which the wells produce water is not available because most of these wells lack geologic logs or other specific construction information.

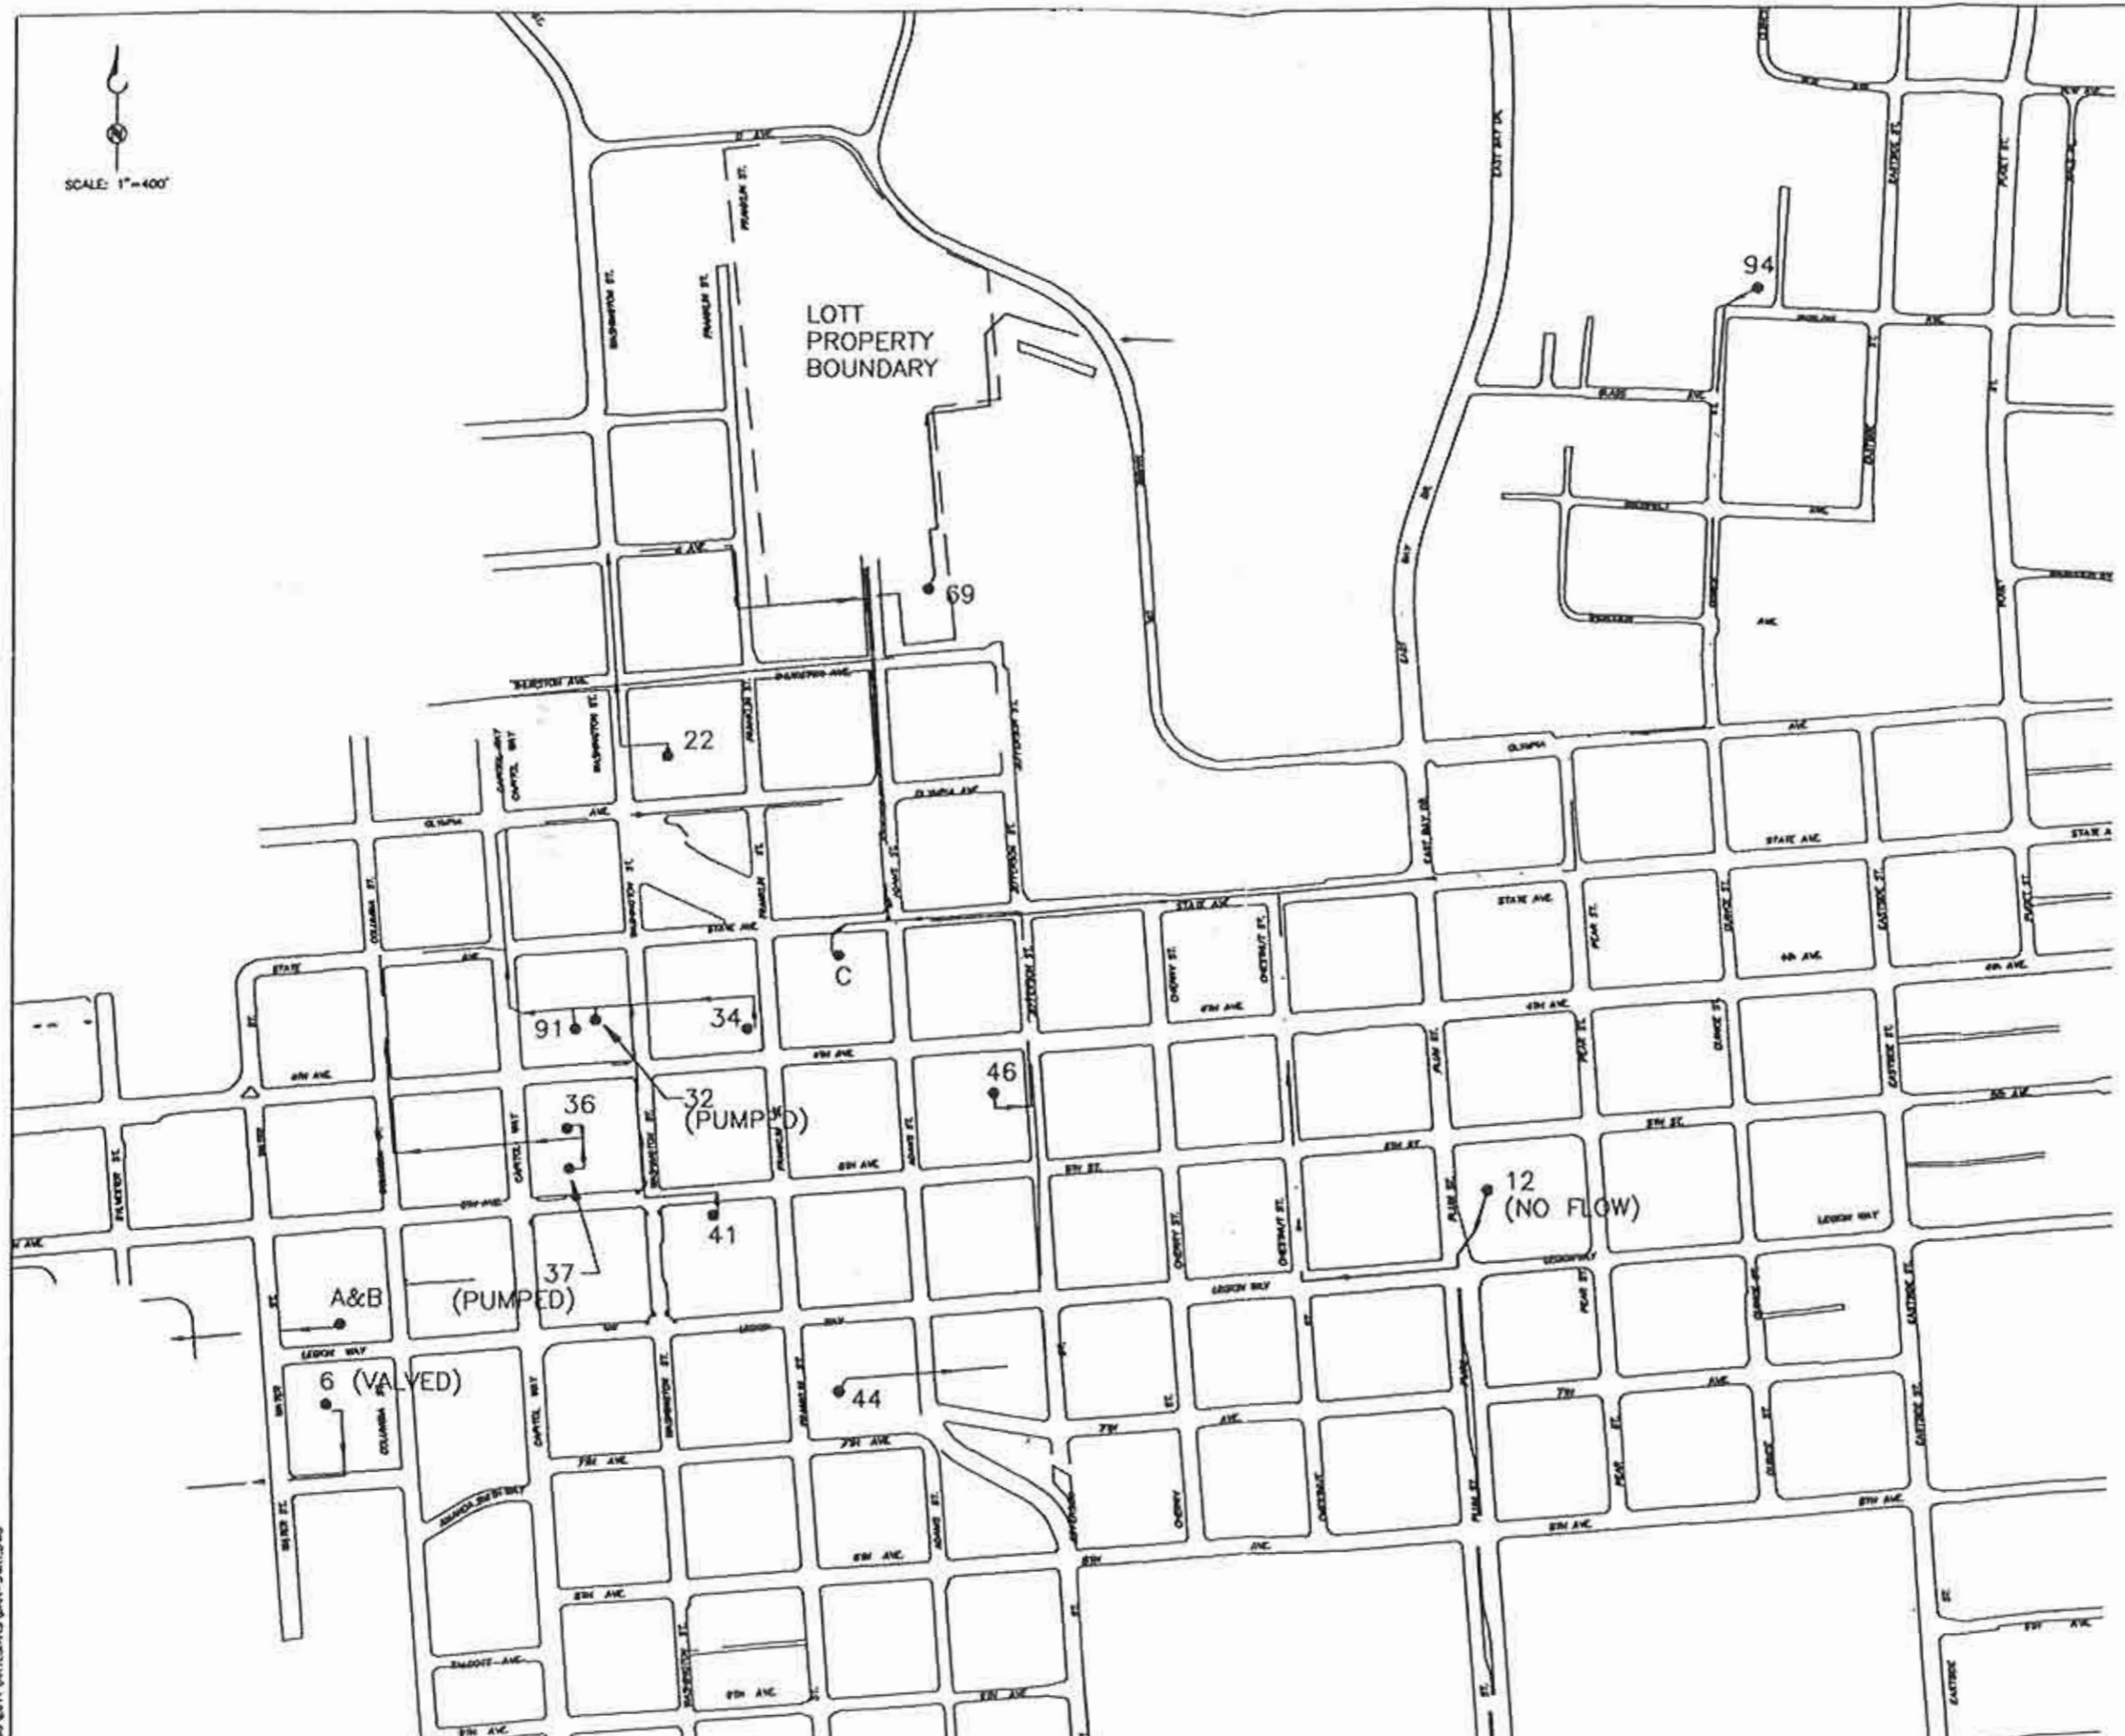
After the field investigation was completed, a probable fate of the water was determined for each well with identified flow (Figure 1-4). This was accomplished by matching the well location with maps of the City's sewer and stormwater drain systems and then determining the most likely entrance point and resulting route for water produced at that site. Table 1-1 lists all 38 wells or springs, their expected routing and discharge point, and an estimate of flow.

Of the 22 wells and springs located, ten were producing water continuously, and three more had controlled flows to the LOTT system. Two more wells should produce water to the LOTT system but currently had no flow. The total produced by these 15 wells is approximately 117 gpm. Using the estimates from the 1994 survey for the same 15 wells, the production becomes 123 gpm. It should be noted that both of these estimates are more likely high rather than low, since those wells with control features are not in constant use and the remainder were estimated using the highest of the flow values identified. The maximum flow estimate for all the wells listed in Table 1-1, assuming all wells exist but excluding those noted as draining to outfalls other than LOTT, is 288 gpm. If this speculation is expanded to address all 96 wells listed in the 1994 survey, again excluding those not expected to discharge to the LOTT system and also those noted as destroyed, the maximum flow to the LOTT system would be 353 gpm. This represents
