TECHNICAL MEMORANDUM 1204
LOTT Wastewater Resource Management Plan

March 26, 1999

Robinson & Noble, Inc.
Tacoma, WA

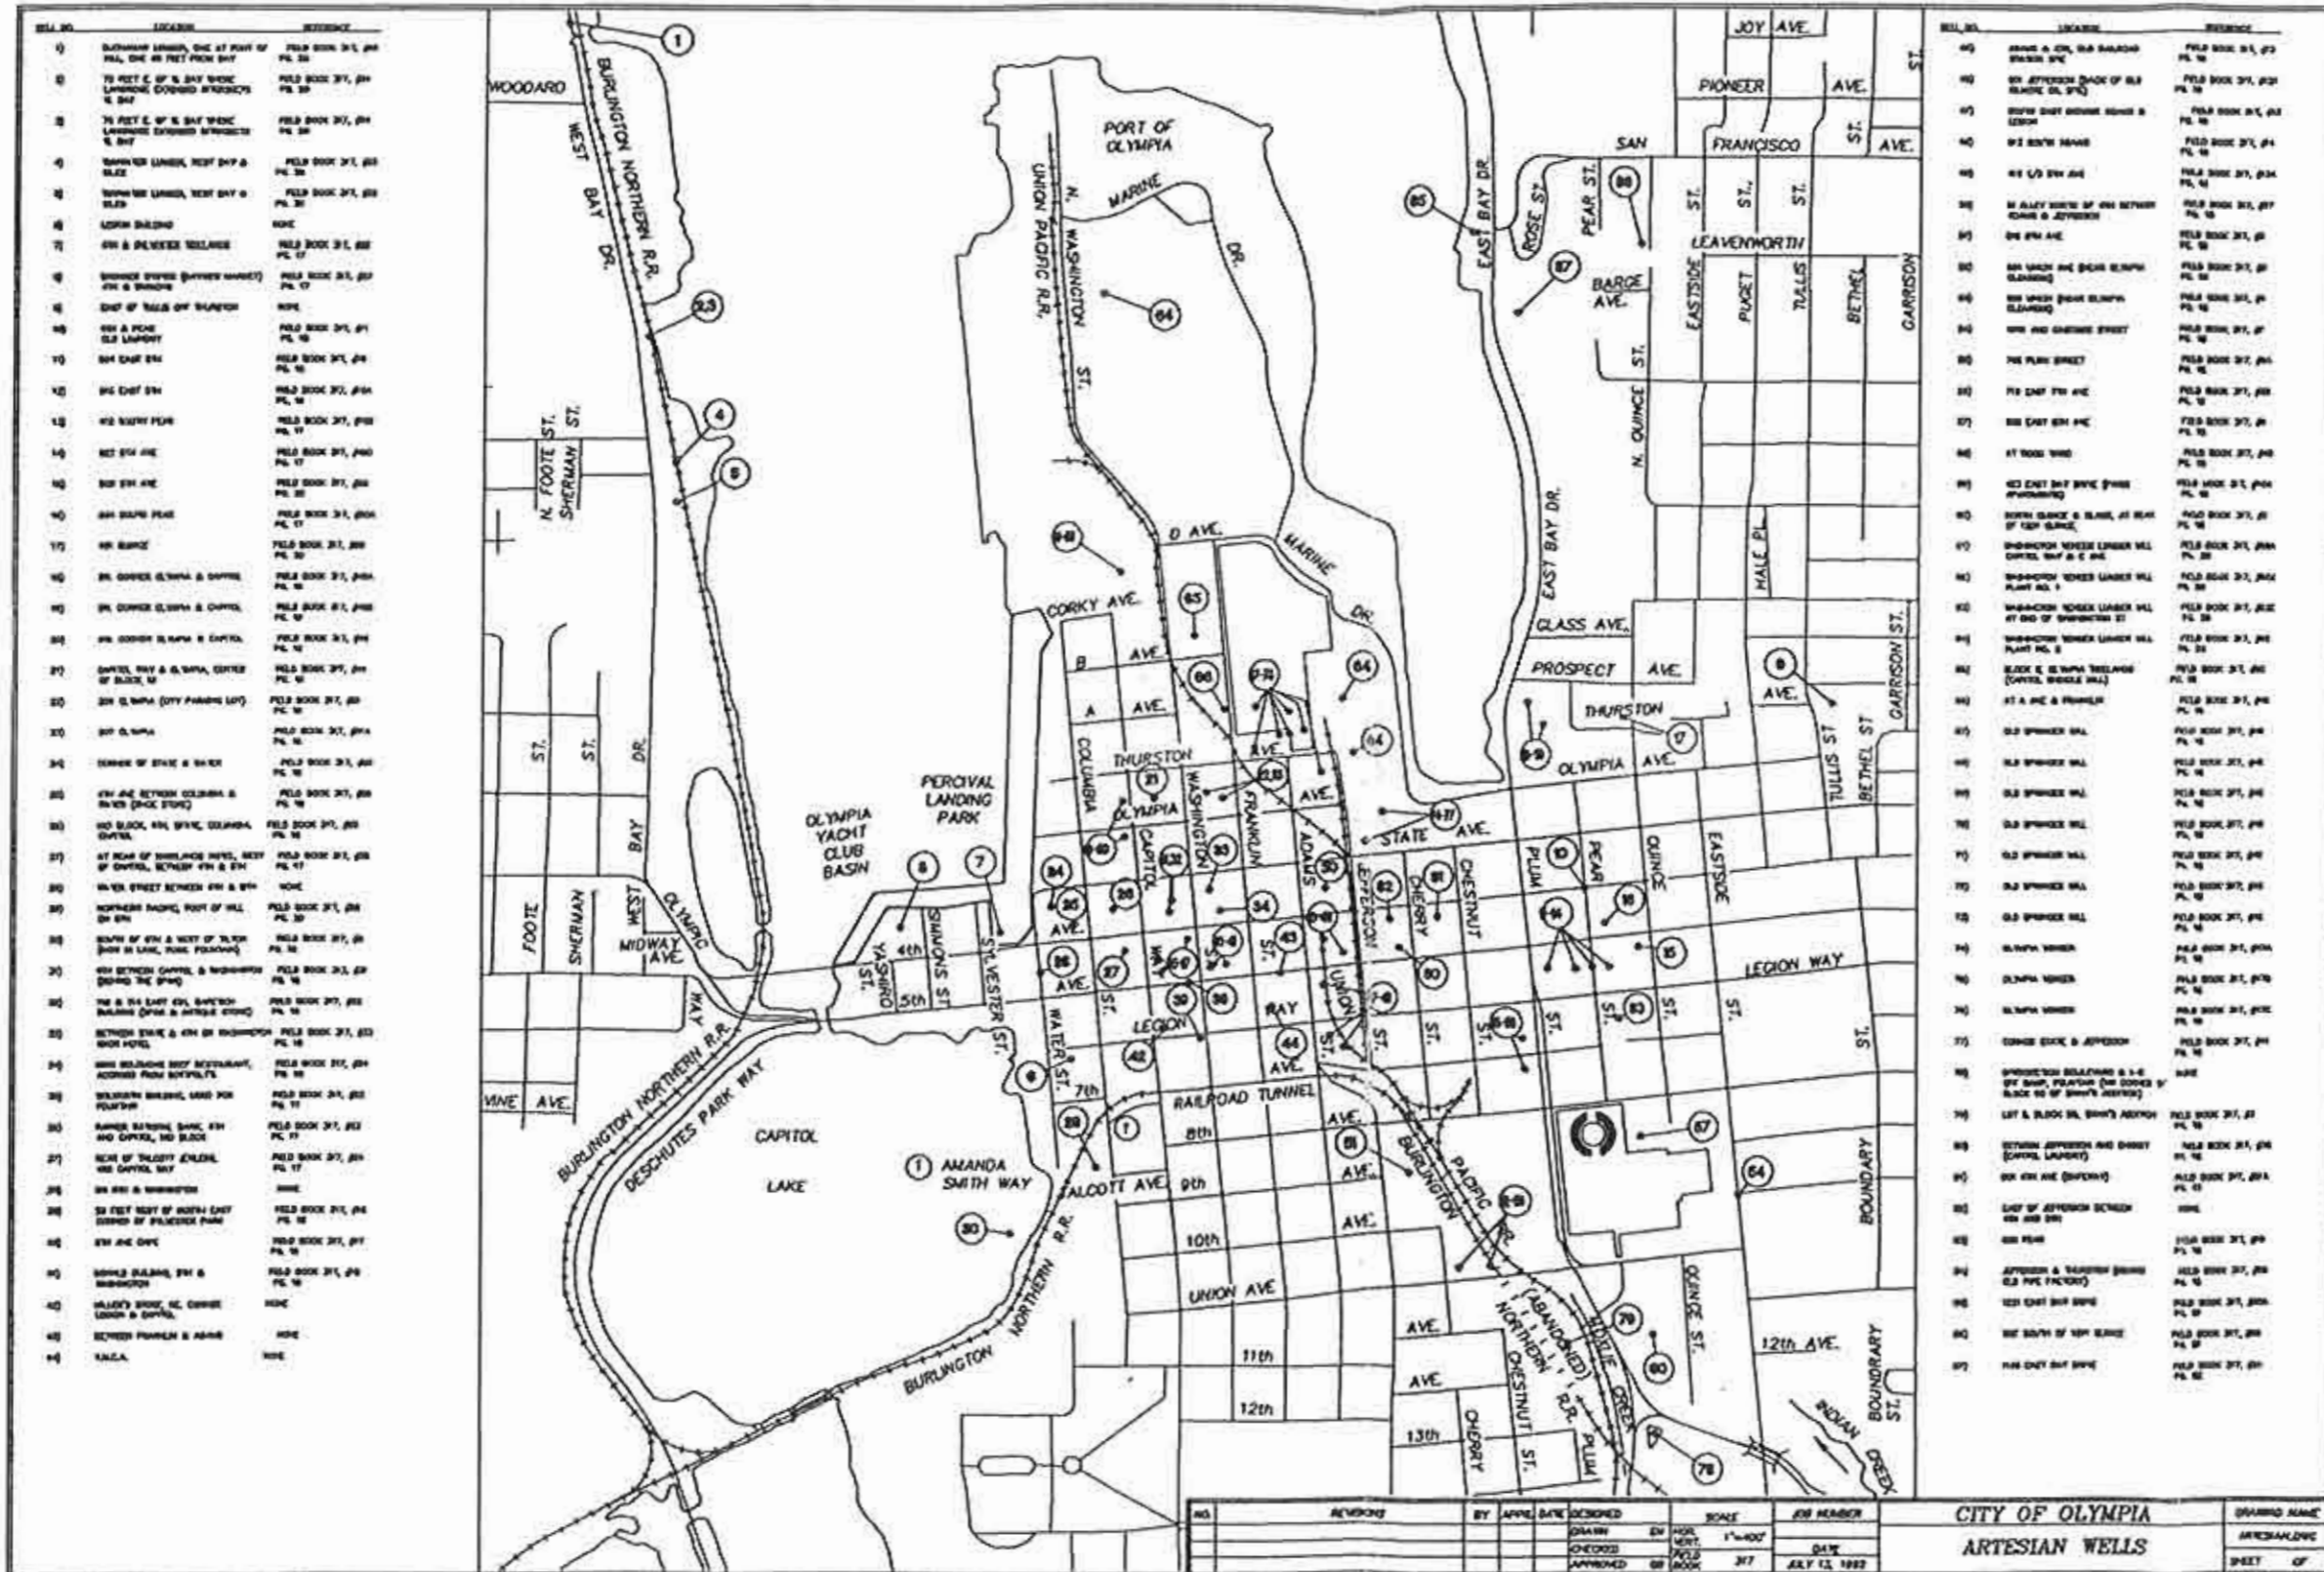
FIGURE 1-1

Our survey investigated 36 reported well sites, locating 19 wells (at 18 sites) and three spring sites. Three of the sites investigated have wells that were apparently previously unknown. Figure 1-1 illustrates the locations of the wells and springs covered in this effort. Figure 1-2 is a reproduction of the well location map from the 1994 Artesian Well Survey by Thurston County Environmental Health Department (TCEHD). That effort originally identified 94 well sites or springs based on information collected in the field and from two previous surveys by the City of Olympia (the first a 1939 to 1943 survey as summarized in Fieldbook 17, and the later an undated survey). The figure shows 86 of the 94 sites. The 1994 survey identified 31 wells as field located.
